CAPITAL PROJECT JUSTIFICATION 2007-2008

TITLE: Unit 2 burner injector / burner replacement

**Intermountain Power Service Corp.
ABT Siemens Warranty Claim**

ABT Siemens Warranty Claim

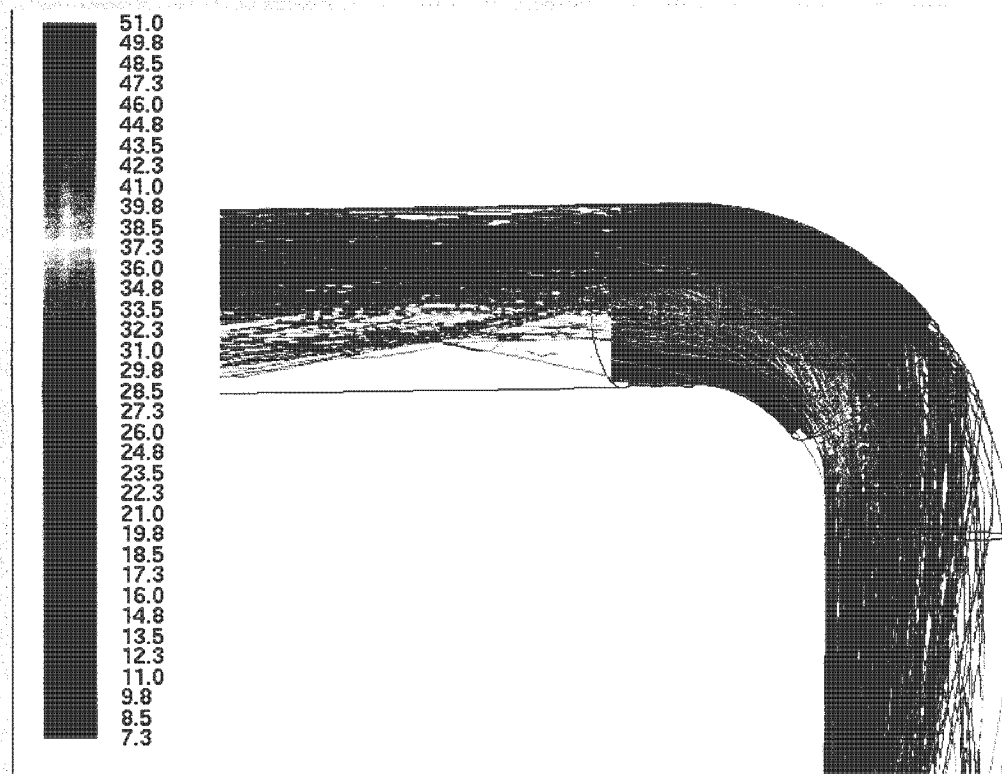
The CFD model shows the coal particles are stratified entering the elbow. The original kicker assembly with the X-vane that was modified to retain the clean out port will not last in the high velocity stream of concentrated coal particles with the higher coal flow.

The revised fuel injector design will increase the cross sectional area of the nozzle to reduce velocities, lengthen and flatten the slope of the transition ramp and replace the round elbow with a "Flat back" design to allow dispersion of the coal particles across the flow area of the nozzle.

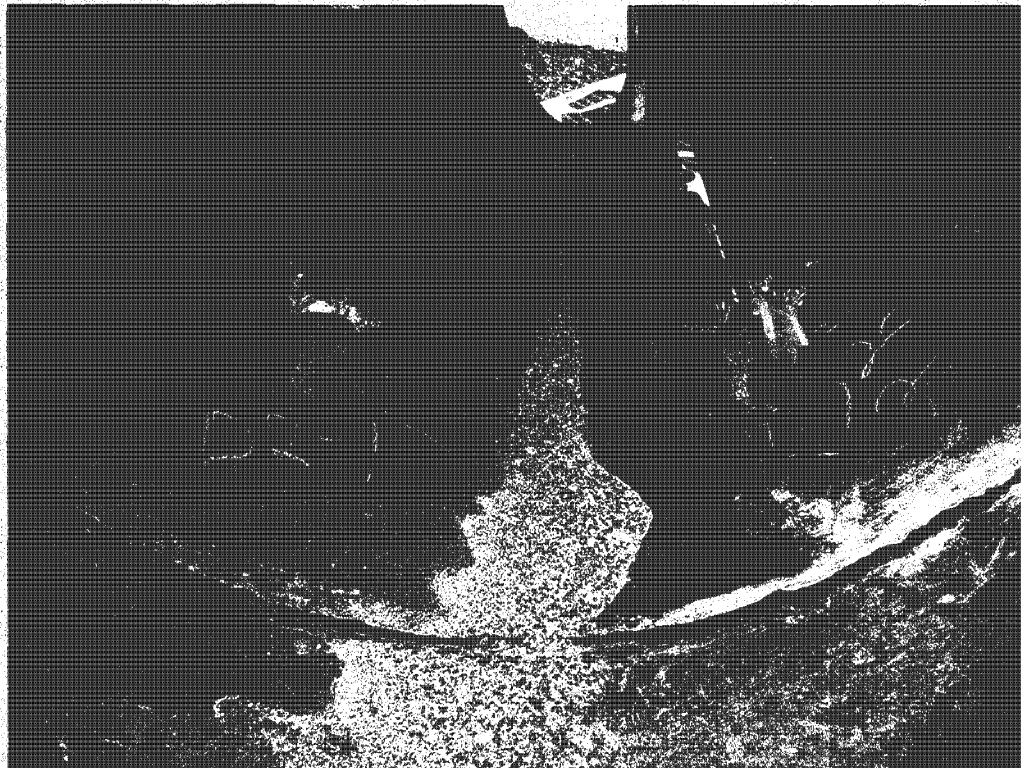
Erosion is originating at the transition slope from the round barrel to the 6 lobe exit. This is consistent with the results of the CFD model. The metallurgical analysis performed by Tordonato Energy Consultants identified erosion as a the contributor cause of the nozzle cracking. The high temperatures at the weld between the nozzle and burner barrel increased the stress which also contributed to the cracking. There was no evidence of corrosion.

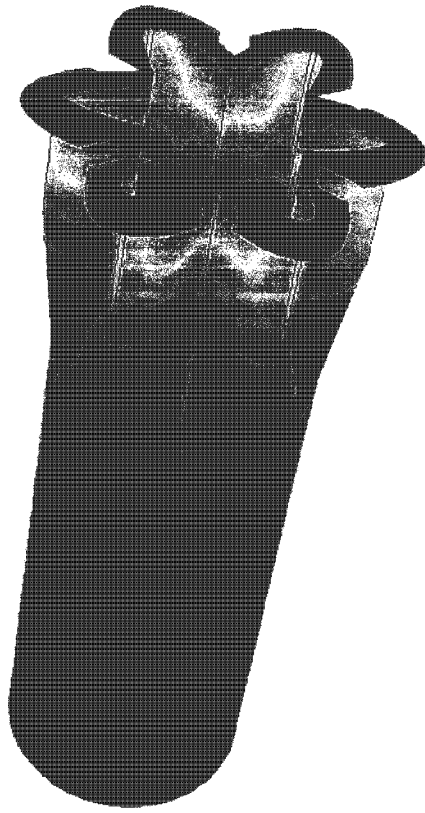
The furnace radiation model shows that the heat conducted back to the burner barrel to be higher than expected. The revised fuel injector will use a spool piece of 253MA stainless steel to make the transition from the nozzle to the barrel. The revised fuel injector shall use refractory tile to shield the burner barrel from radiation from the furnace and to minimize erosion. This thermal model does not model the cooling of the secondary air on the tip.

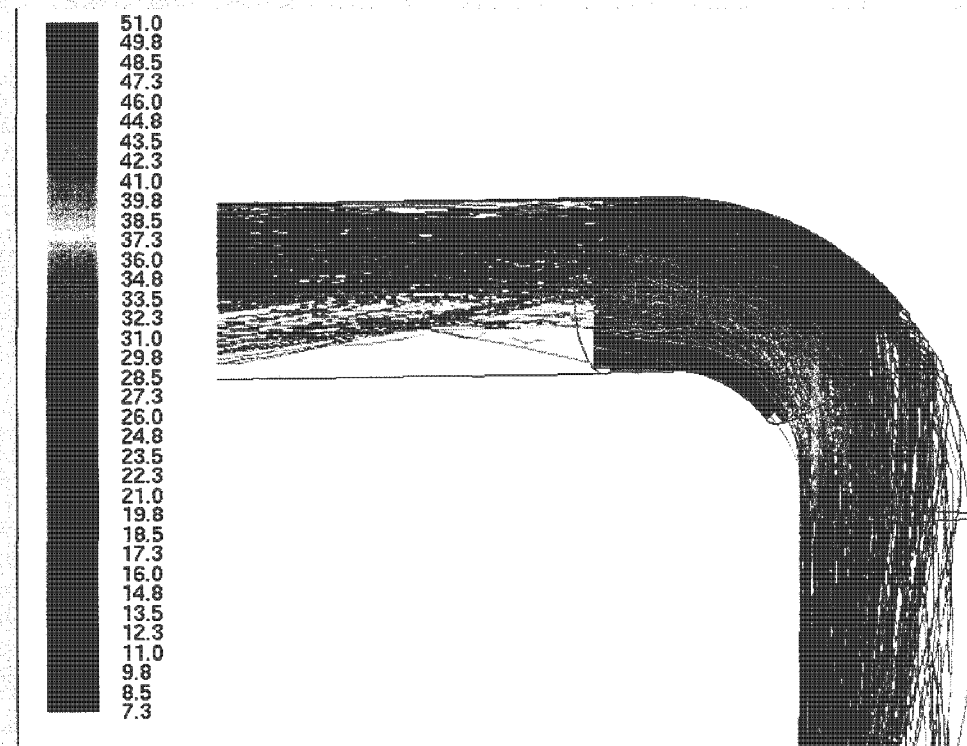
The CFD model shows the coal particles are stratified entering the elbow. The original kicker assembly with the X-vane that was modified to retain the clean out port will not last in the high velocity stream of concentrated coal particles with the higher coal flow.

The revised fuel injector design will increase the cross sectional area of the nozzle to reduce velocities, lengthen and flatten the slope of the transition ramp and replace the round elbow with a "Flat back" design to allow dispersion of the coal particles across the flow area of the nozzle.

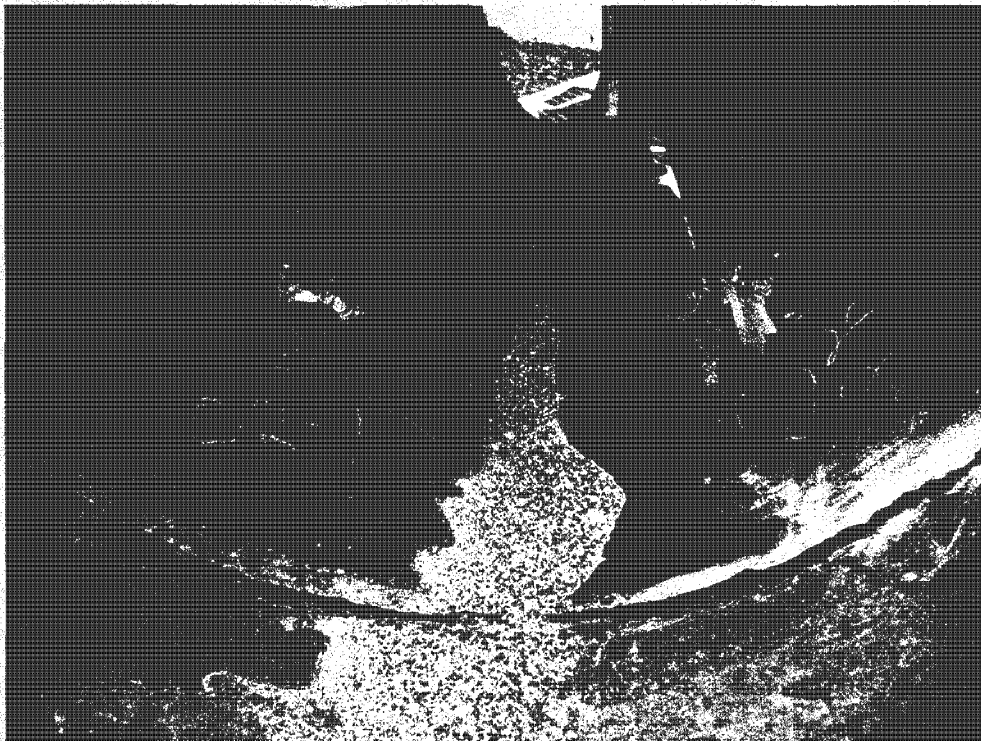
Erosion is originating at the transition slope from the round barrel to the 6 lobe exit. This is consistent with the results of the CFD model. The metallurgical analysis performed by Tordonato Energy Consultants identified erosion as a the contributor cause of the nozzle cracking. The high temperatures at the weld between the nozzle and burner barrel increased the stress which also contributed to the cracking. There was no evidence of corrosion.

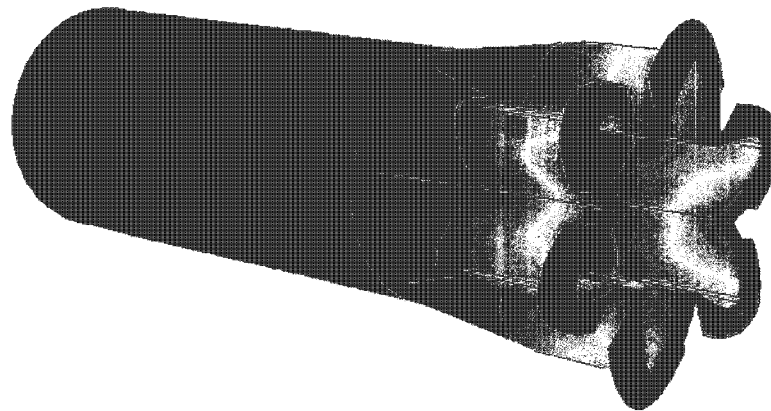
The furnace radiation model shows that the heat conducted back to the burner barrel to be higher than expected. The revised fuel injector will use a spool piece of 253MA stainless steel to make the transition from the nozzle to the barrel. The revised fuel injector shall use refractory tile to shield the burner barrel from radiation from the furnace and to minimize erosion. This thermal model does not model the cooling of the secondary air on the tip.
